FlightLine

A Monthly Publication of Collins Model Aviators

August 1996

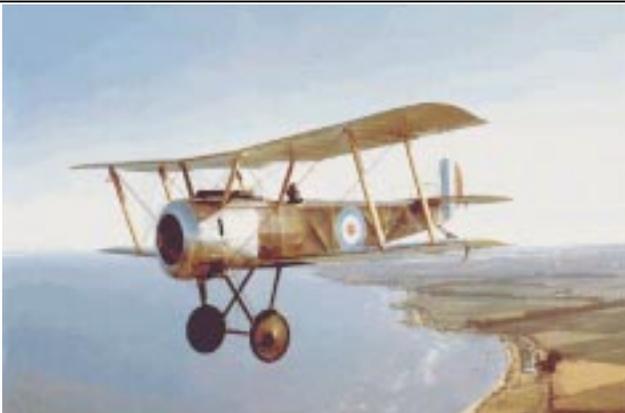
August's Featured Model — Sopwith Pup in flight from Allan Wright's W.W.I modeling Web page

The Sopwith Pup (also known as the Scout Tractor) was the precursor to the famous Sopwith Camel. The Camel was the most successful fighter of World War I, shooting down more enemy aircraft than any other plane of the war. But the Pup was memorable in it own right. The Pup had excellent

The Pup had a slight edge in speed and was considerably more nimble, but with its single machine gun it was at a distinct disadvantage to the firepower of the DI and DII's

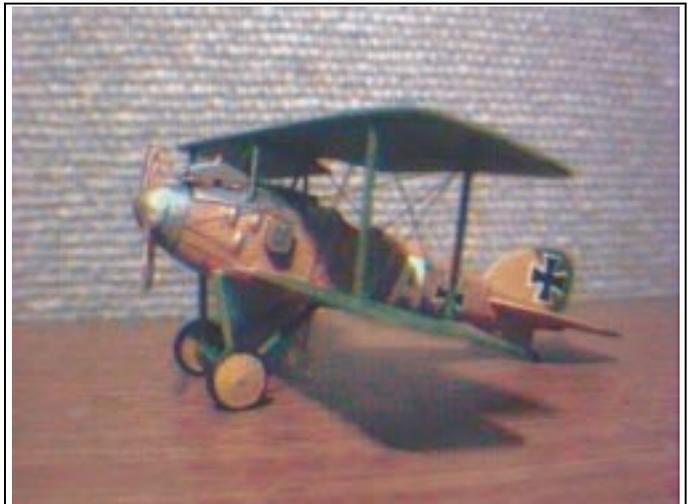
Allan Wright's W.W.I Albatros model

Allan Wright's Albatros model shown in the picture is actually a DIII kit modified to look like a DI by adding scratch built wings, wing struts, Windorf radiators, radiator overflow tank, and modifying the tail position and fuselage shape.

The Albatros was a very successful fighter that lead quickly to a slightly improved version the Albatros DII. The DII had better forward visibility but was basically the same design as the DI. The DI was an innovative fighter that won back the air from the D.H.2 and Newport 17. Its twin machine guns gave it more firepower than the single gunned British and French aircraft of the time, and its powerful liquid cooled engine and streamlined fuselage shape gave it good performance even though it was nearly twice the weight of the Pup.
